CPR CLASSIC EAST, e Letter

January 2019

Leading Basics and Installation Guide

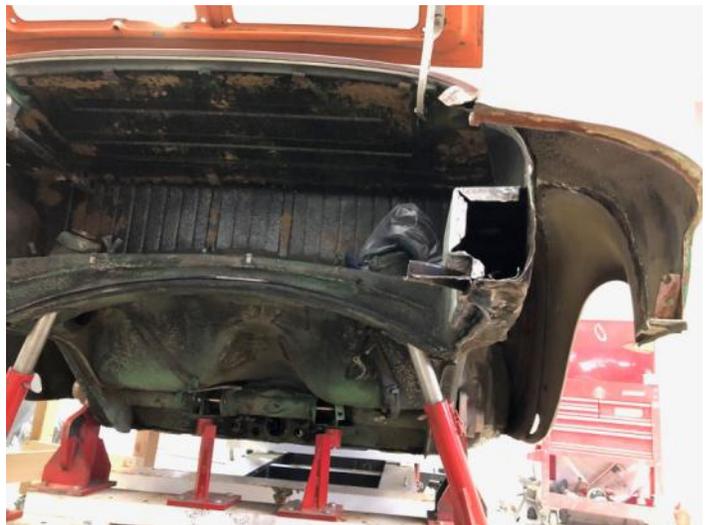
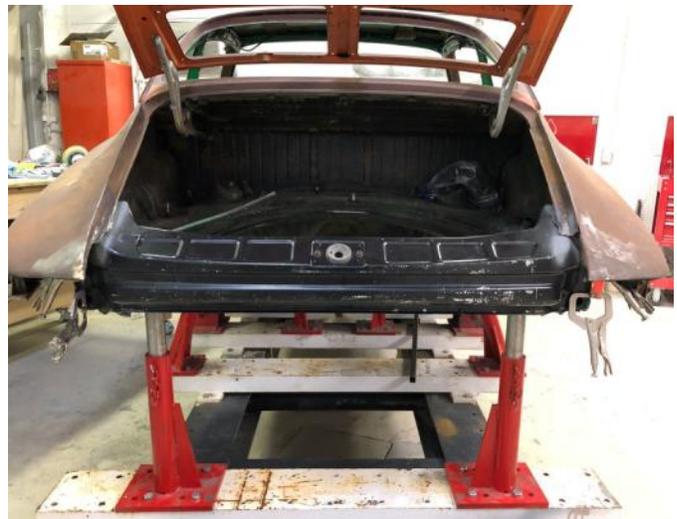
John, has been working on his Porsche for years, but he reached a point where he did not have the equipment to verify that his 911 was Factory Straight. John felt there were many signs that pointed to an impact to the rear of the 911, and he was uncomfortable continuing with his restoration until he answered the “straightness” issue.

While there was noticeable impact damage the frame alignment came into factory spec quite quickly. With a little pulling and persuading, John’s 901 body was in factory spec.

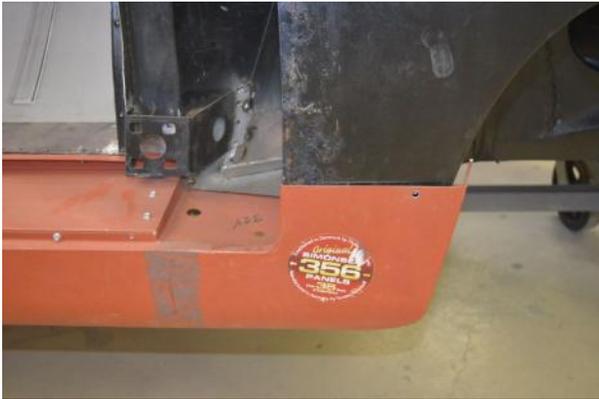
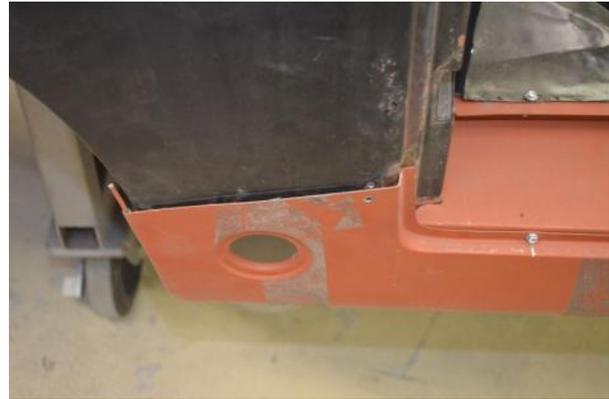
These owner purchased panels don't fit. Never would. Never could. Clearly, the Craftsmen in the CPR Classic East Metal Shop can make them fit this 354 correctly. That in itself is not the problem. The problem is, that the customer was not told by the manufacturer of this rocker panel, that it would not be a direct fit item - and it would take considerable work to make them fit properly. It is bad enough that we at CPR have to correct the problem, and charge the customer for a short coming of the company who sold these panels. It could be much worse if the customer was going to install this rocker panel him/herself. I can only imagine the rage, when a customer in installing this, reached the point we did - It don't fit!

Sad truth, we probably could have made the panel from scratch cheaper than fixing this one. That is not always true for every non-factory replacement panel, but more than we would like to see.

TIP - If you are going to install panels that you order, try ordering it from a Porsche authorized dealer. Factory stamping is usually crisper and more accurately stamped. If you have no other choice, ask the non-factory manufacturer of a panel if it will fit, and if it doesn't, what is their remedy. You may find out more with this Q&A than you want to know.

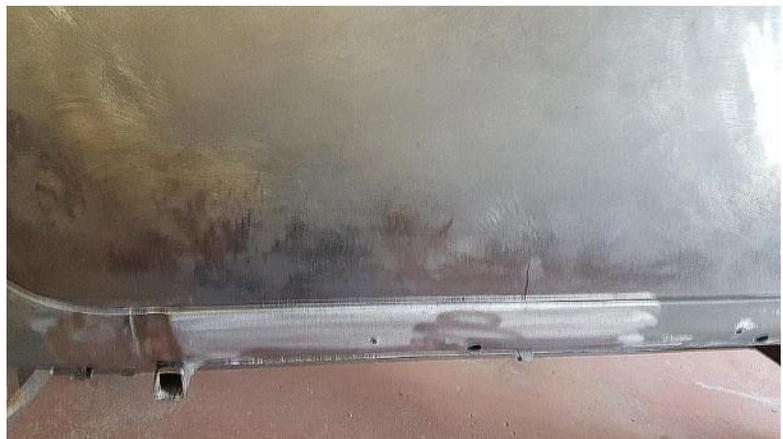
In *Image 1*, you can see that the area we will be working on is the factory seam where the rocker and the quarter panel meet, just above the jack post. This area has been cleaned, prepped and is ready for the lead work to begin.

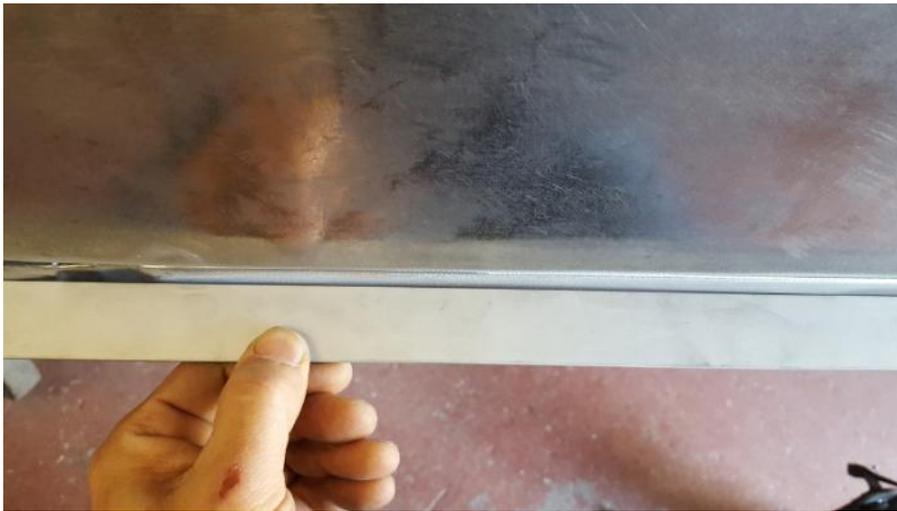
In *Image 2*, you can see the seam on the left but you can also see on the right, that the rocker edge is below flush in relationship to the quarter panel and the bottom door edge. We will be addressing both of these issues during this repair.

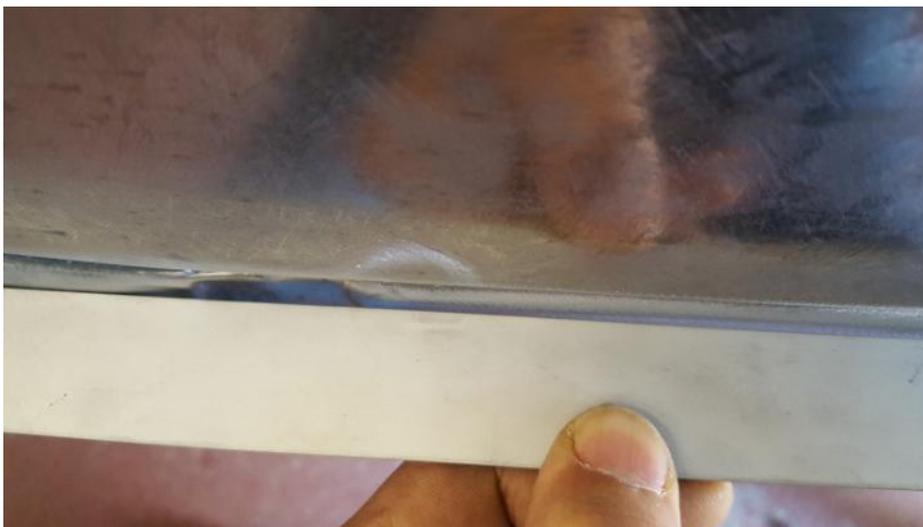
In *Image 3*, take notice of the 3/32" gap, that at just few feet away looked negligible, but up close looks clearly out of place.

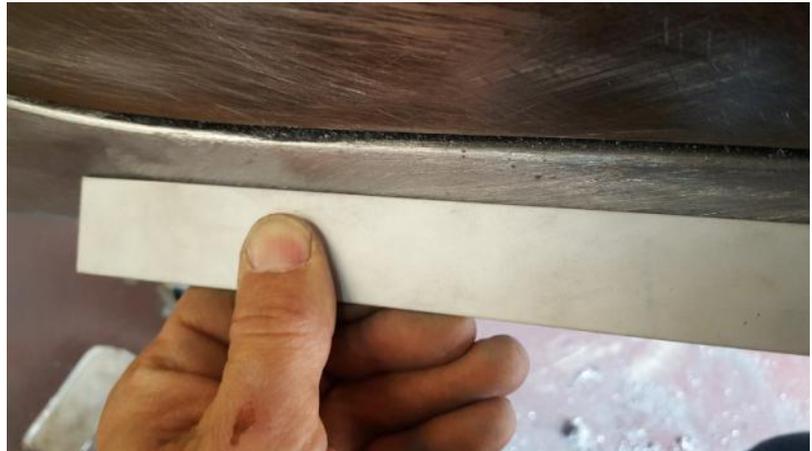
In *Image 12*, we are taking a closer look at our accuracy. We can see the the area that was the lowest in the beginning is now slightly too high. This will better match the natural contours of the door, but does require a little more filing.
