CPR CLASSIC EAST, e Letter

January 2019

Leading Basics and Installation Guide

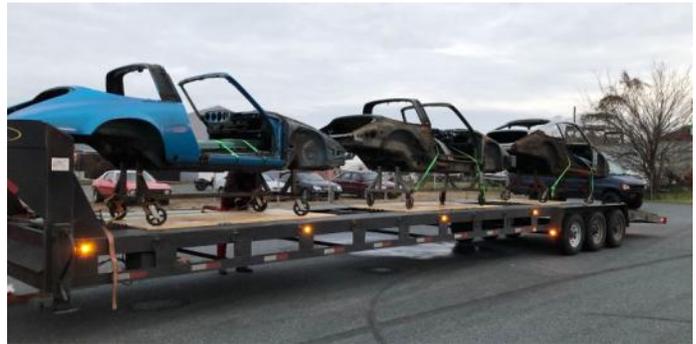
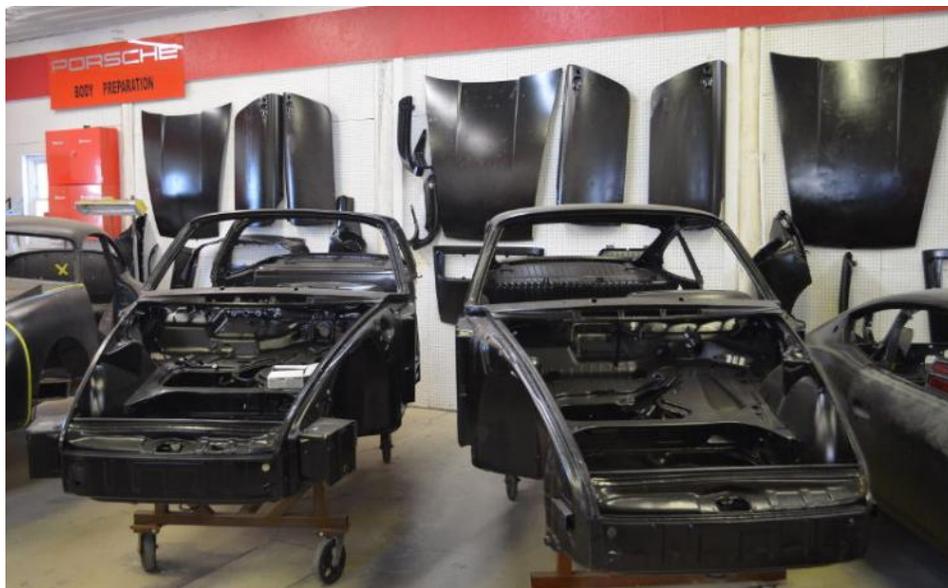
The three 901/911 bodies are back from being stripped to bare metal and E-coated. These two processes leave the body framework in a fantastic condition for a great starting point of any Porsche revitalization. These two processes attack and eliminate 98% of the rust on every surface of the Porsche panels - inside and out.

E-coating is, in our opinion, the premier process and approach to restoration. This gives CPR, and in turn our customers, the confidence to state that their Porsche received the ultimate “state of the art” rust prevention longevity.

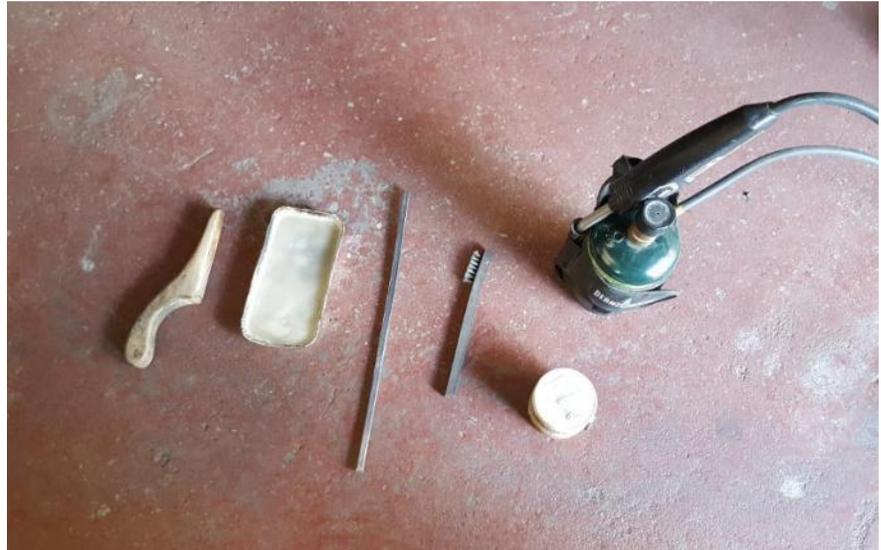
Image 4, shows some of the basic tools we will need to do our lead installation. From left to right, we have a smoothing paddle, tallow, our lead, a brush and Flux-N-Solder™ (the tinning product, which will be referred to simply as flux for the remainder of this article) followed by our heat source.

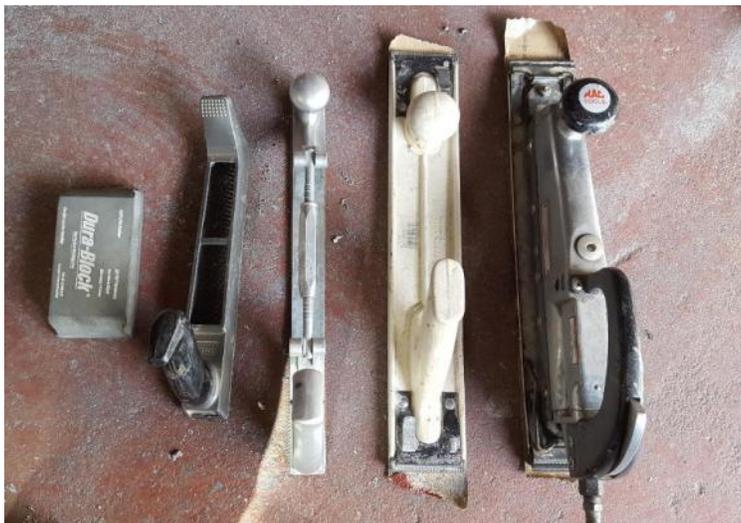
Image 9, shows some of the basic tools we will need to metal finish our lead installation. From left to right we have a hand block, 2 body files and 2 inline sanders. Note: lead is a contaminant and is not intended to be sanded. Most of the finishing will be done with the body files to keep the dust down. The sanding is used only as a visual guide to locate the highs and lows, like you would when doing traditional body work.

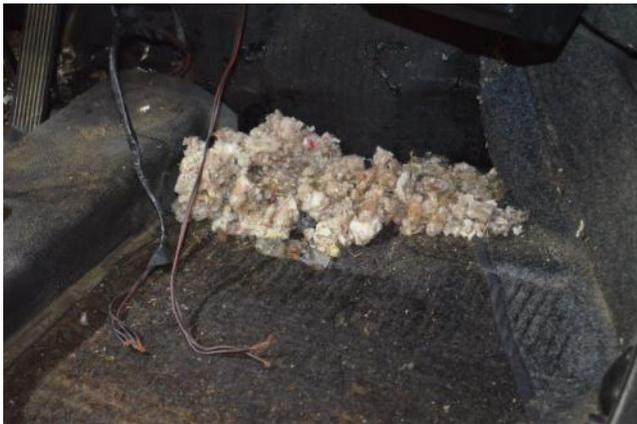
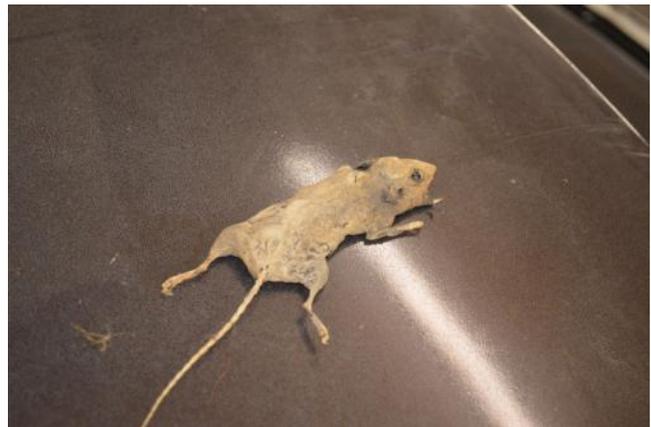
When a Porsche goes into disassembly here at CPR
... we always encounter the unexpected.
